Lightning Creek Watershed Assessment Level II Cross Section Surveys Summary

Lightning Creek Watershed Assessment

PWA Ref # 1621

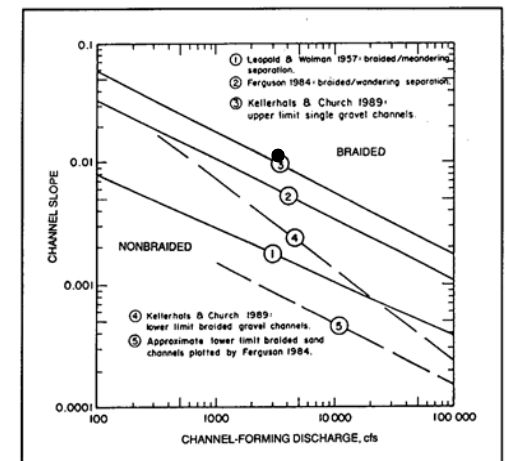
Figure 2-24. Slope-discharge chart distinguishing braided from non-braided channels

The stable form of Lower Lightning Creek tends more toward a braided than a meandering channel based on historic aerial photo interpretation and the current slope-discharge relationship.

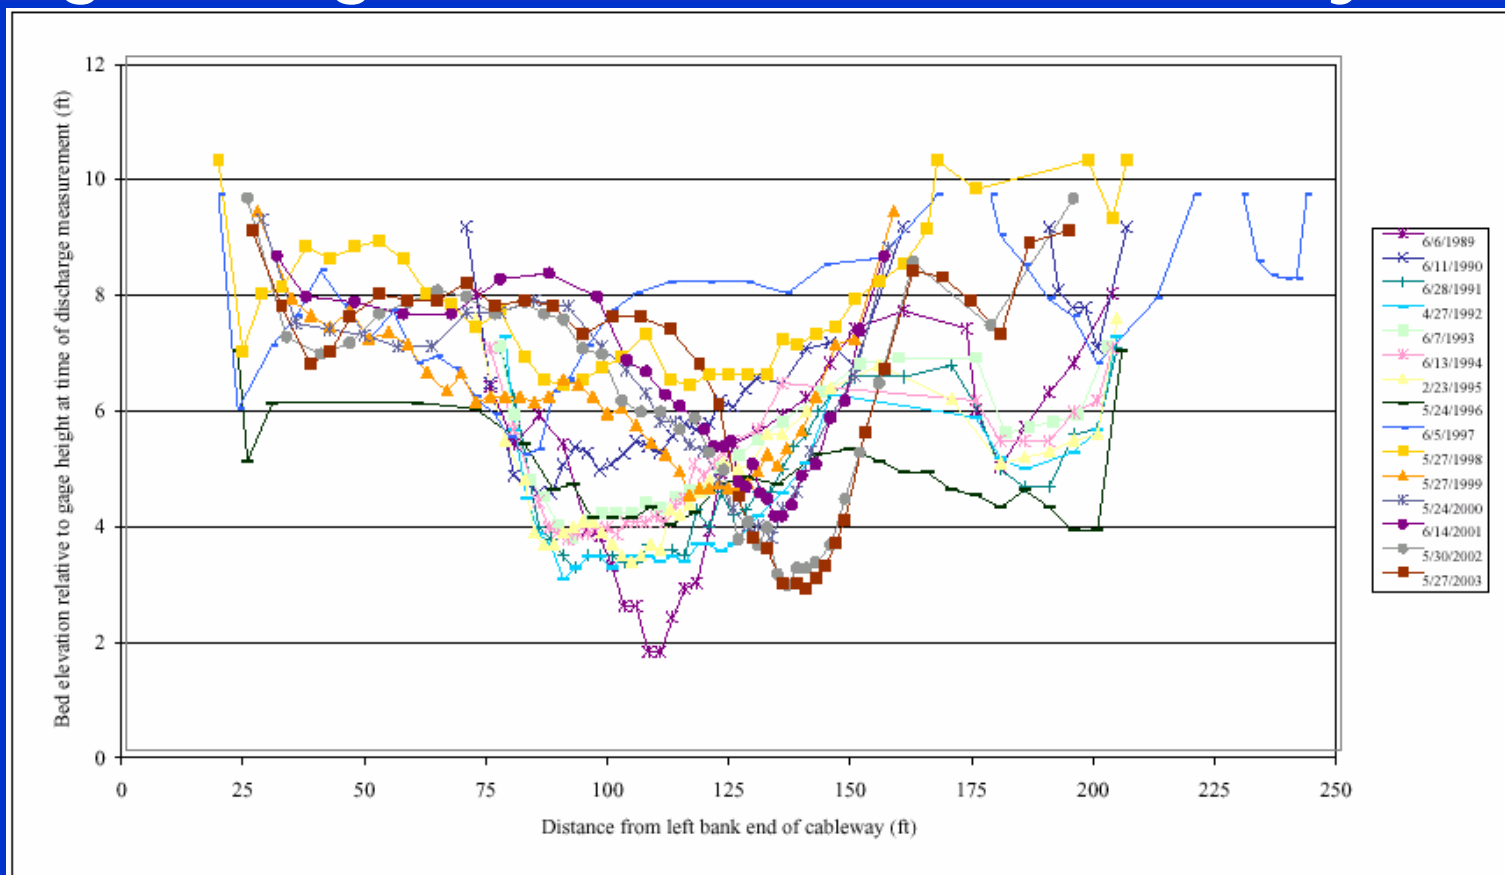
Lower Lightning Creek Cross Section at USGS Cableway, 1989-2003

The dynamic nature of the channel should be incorporated into the long-term management of sediment, floods, and fish passage through the lower reach.
